**DAMAGE CONSIDERATIONS OF A FLEXIBLE MICRO
AIR VEHICLE WING USING 3-D LASER VIBROMETRY**

THESIS

Leo L. Mendoza Jr., ENS, USN
AFIT/GAE/ENY/07-J13

AIR FORCE INSTITUTE OF TECHNOLOGY

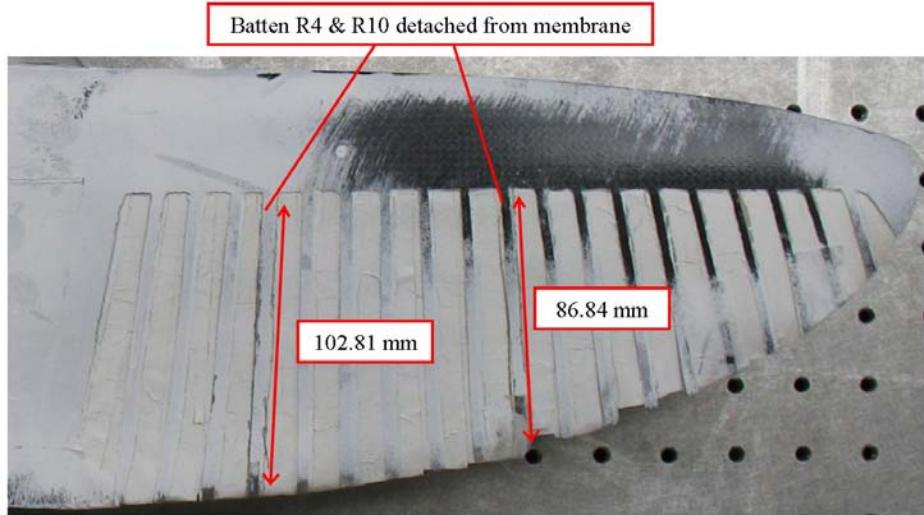
Figure 15: Test 1, Right Span Wing Damage

In Test 1, the right span of the wing had two battens that had detached from the membrane, R4 and R10. Batten R4 is 102.81 mm long and approximately 47 mm from the center of the wing. Batten R10 was 85.84 mm long and approximately 126 mm from the center of the wing. The left span of the wing also had a batten that detached, batten L8. Batten L8 is

93.03 mm long and approximately 93 mm from the center of the wing. There were also three on the membrane and a crack that extended during testing. These three cuts and the crack will be discussed further in Chapter 4. Figure 15 and Figure 16 show damage on the wing during Test 1.

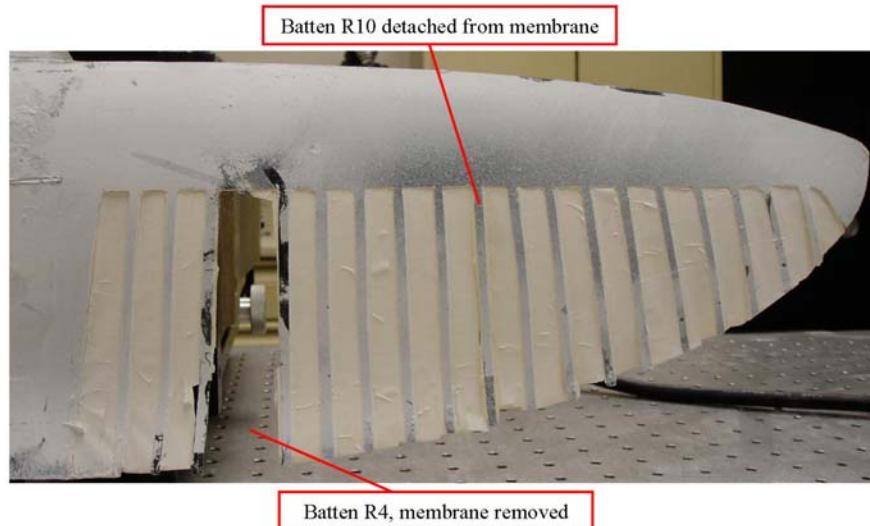
Figure 17: Test 2, Right Span Wing Damage

For Test 2, damage was intentionally applied to the wing. On the right span, batten R10 remained the same as in Test 1. Batten R4 was cut and removed from the wing along with its surrounding membrane. On the left span of the wing, the three cuts in the membrane, extended crack, and detached batten L8 remained the same as in Test 1. Near the tip of the left wing, batten L17 was cut and removed along with its surrounding membrane. Figure 17 and Figure 18 show the damage on the wing during Test 2.

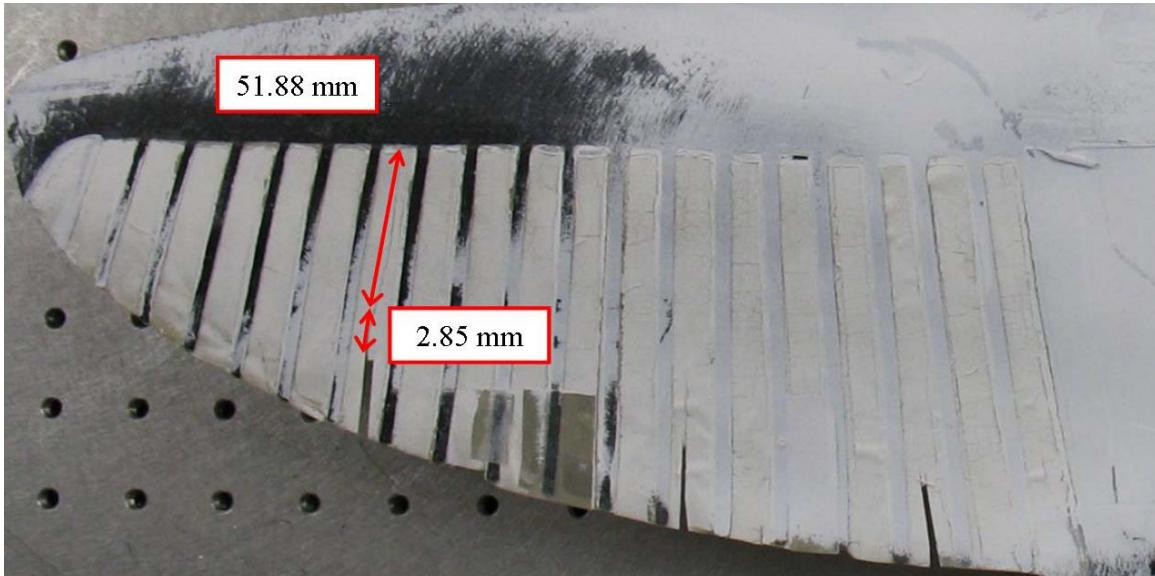
Figure 19: Membrane Crack Dimensions

Before testing, the crack in the membrane was originally 2.85 mm long, a short extension of the intentional cut made into the wing. However, during testing the crack grew to 54.73 mm long, extending all the way to the top of the membrane up to the leading edge of the wing. Because of the complex three dimensional geometry of the wing, the wing encountered three modes of fracture mechanics: Mode I, Mode II, and Mode III.

- Cracks and their extension or growth become an area of concern for structural integrity when they are further away from the center of the wing. Through investigation of the membrane crack growth, it was seen that cracks near the center of the wing were unaffected during testing. However, the crack furthest from the center of the wing extended at the beginning of testing. Moreover, this crack extended even at the small velocities experienced by the wing.

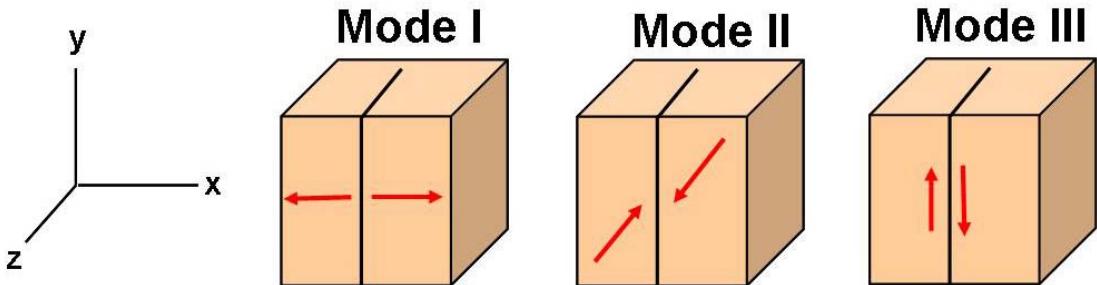
Figure 20: Fracture Mechanics Modes I, II, and III

Mode I is an opening or tensile mode with a tensile stress normal to the crack. In this mode, the crack faces are pulled apart. Mode II is a sliding or in-plane shear mode where shear stresses are acting parallel to the plane of the crack and perpendicular to the crack front. Mode III is a tearing or anti-plane shear mode with shear stresses acting parallel to the plane of the

crack and parallel to the crack front. These three modes are illustrated in Figure 20. During testing, the wing experienced a combination of the three modes shown in Figure 21. With velocities in the x-direction, Mode I opening can be seen as the membrane is pulled apart in opposite directions. Vibrations in the y-direction exhibited Mode II tearing where shear stresses acted parallel on the membrane of the wing. With z-vibrations, Mode II sliding can be seen as the wing's membrane flapped.

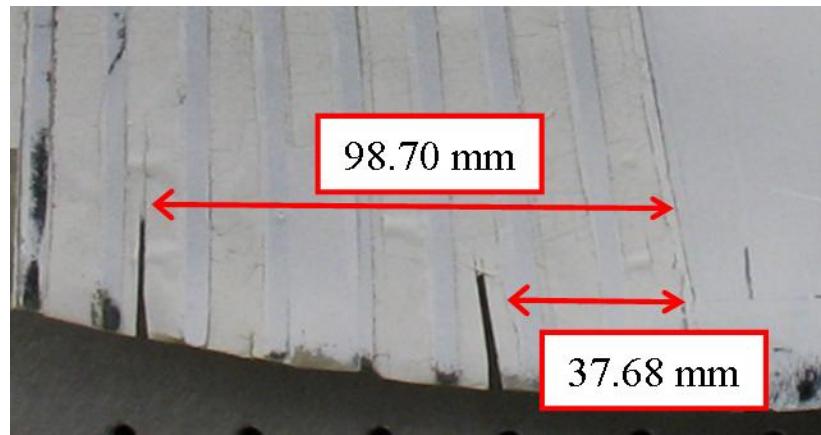
Figure 22: Two Cuts Near Center of Wing

The two cuts near the center of the wing were not affected. The nearest cut was 37.68 mm from the center of the wing and the second was 98.70 mm. The cut where the crack extended was 256.56 mm from the center of the wing. Examining velocities at two scan points,

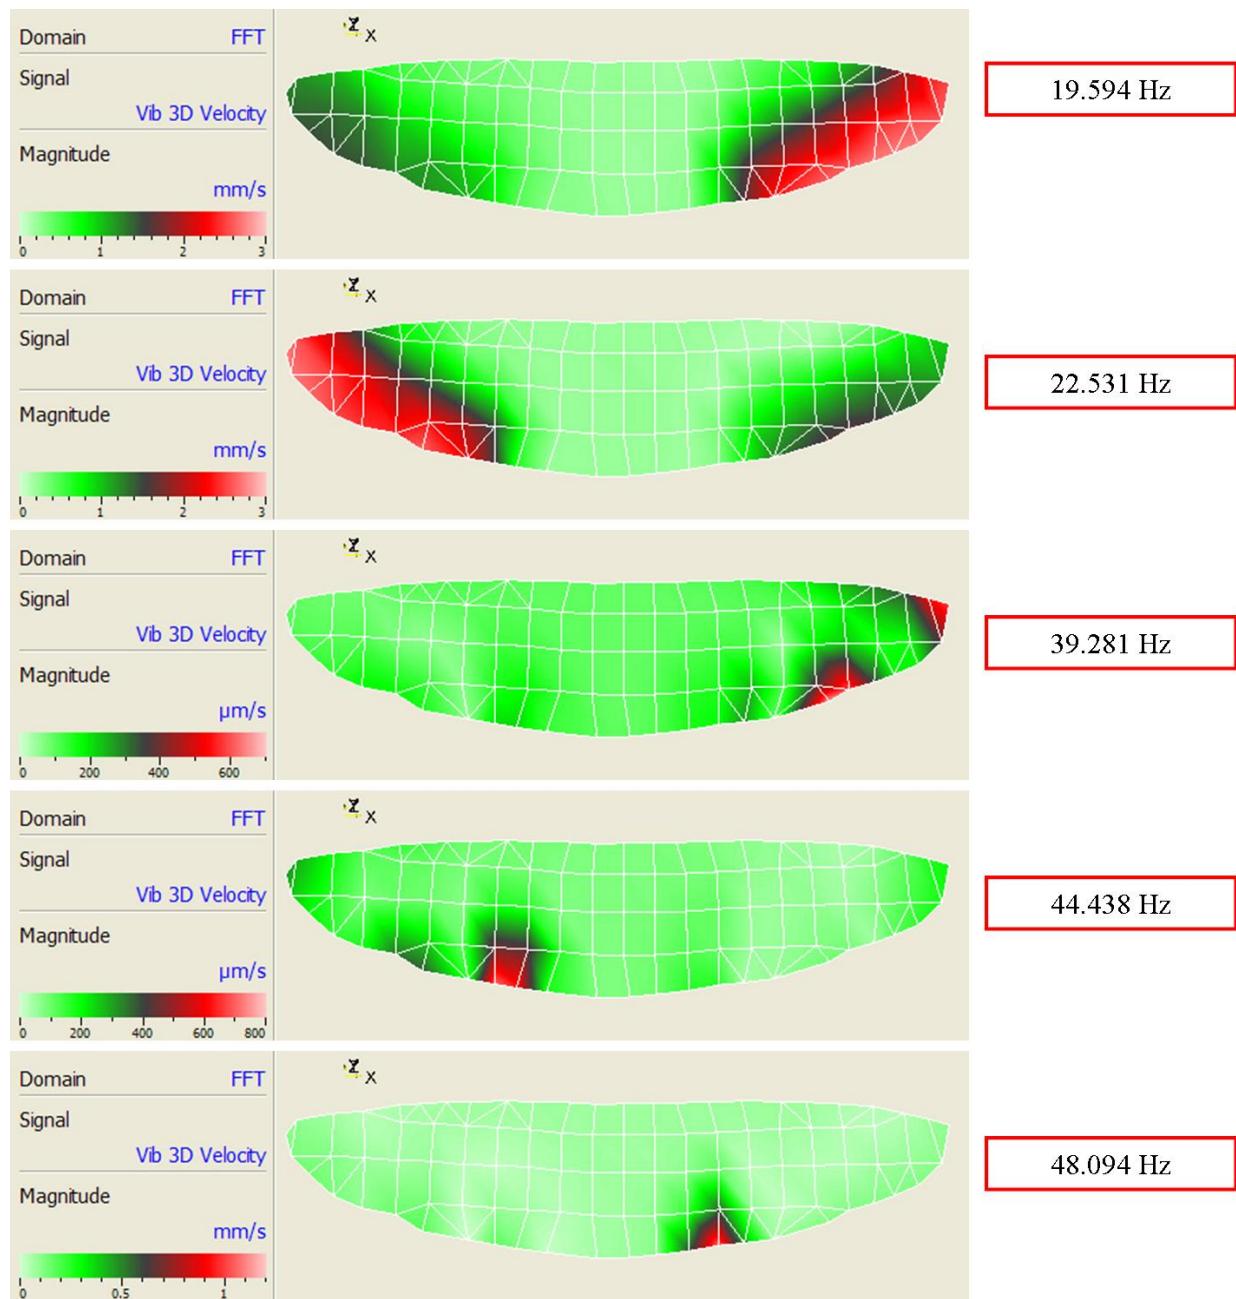
Figure 27: Test 1 Mode Shapes

Figure 24 through Figure 26 show the frequency response functions for Test 1 averaged across the entire wing. Table 4 shows a summary of the natural frequencies of the wing in Test 1. The first mode of the wing is found at 19 Hz, the dominant frequency during testing. The second mode is found at 22 Hz. The third natural mode of the wing is found at 39 Hz. The fourth and fifth modes are found at 44 Hz and 48 Hz, respectively.

The first mode shape of the wing exhibited a somewhat asymmetric flapping motion with larger displacements found on the right span of the wing. The second mode was a symmetric flapping motion with larger displacements found on the left span of the wing. At 39 Hz, the right span of the wing had an s-bending mode shape with relatively little motion on the left span of the wing. At 44 Hz, the opposite occurred. The fourth mode exhibited an s-bending mode shape on the left span of the wing with relatively little motion on the right span. The fifth mode was dominated by motion on the right span of the wing around the area where batten R4 had detached. The five mode shapes of the wing in Test 1 are illustrated in Figure 27.

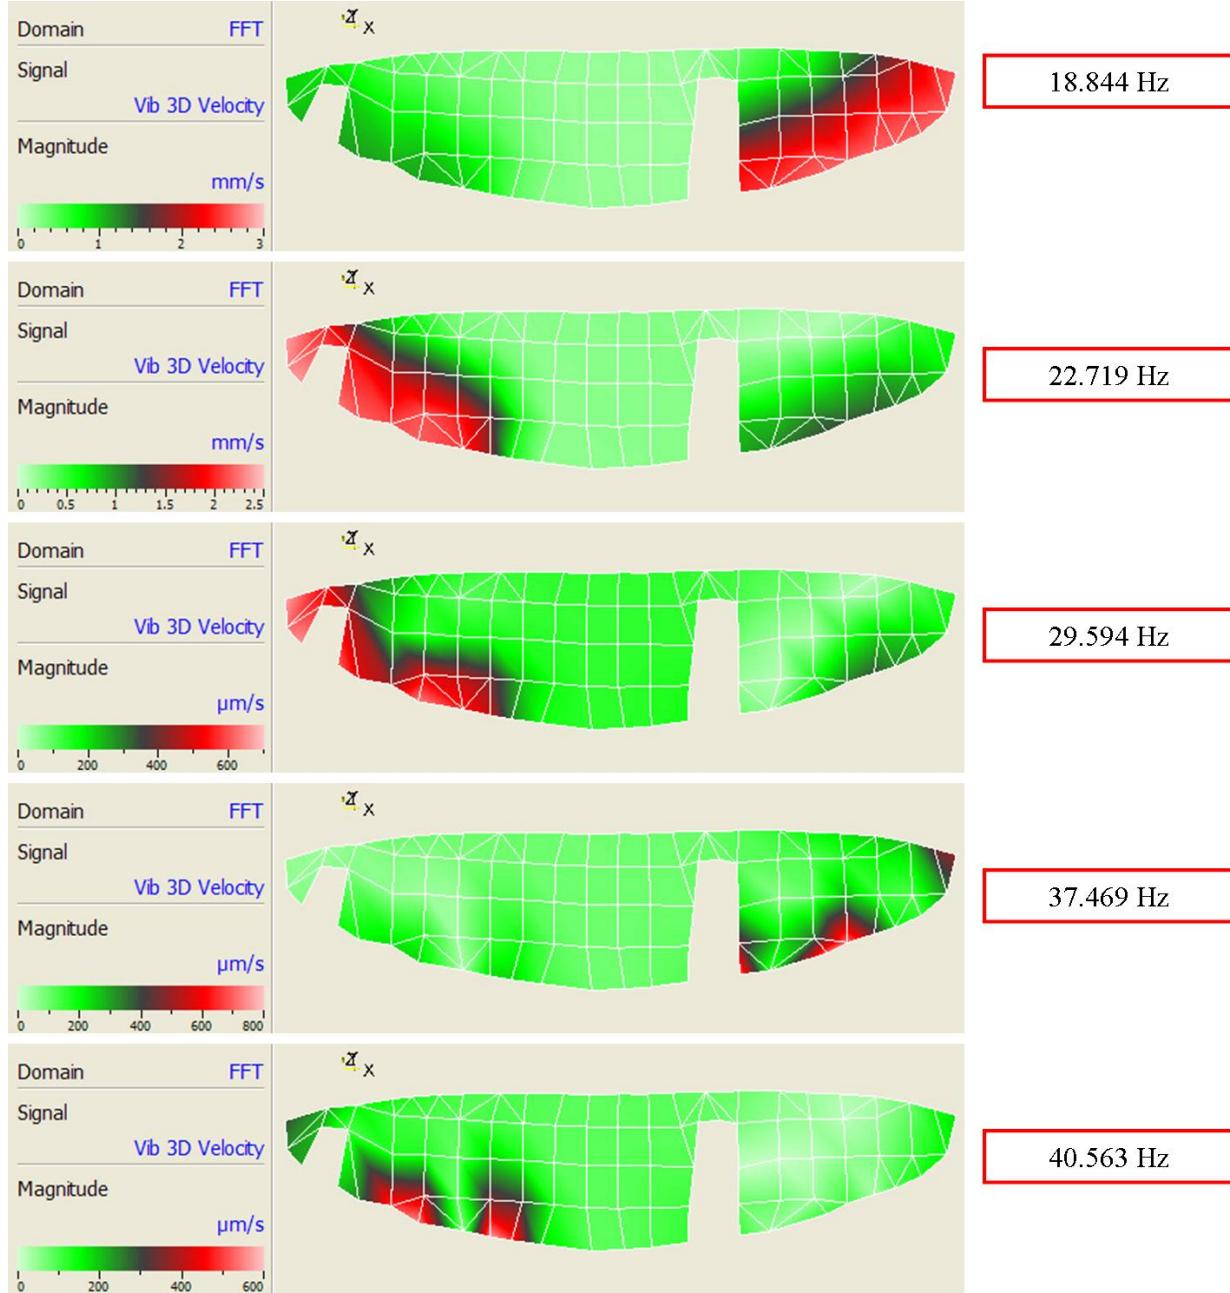
Figure 33: Test 2 Mode Shapes

The mode shapes of the wing in Test 2 are illustrated in Figure 33. The first two mode shapes for the wing in Test 2 stayed relatively the same. The first mode was an asymmetric flapping while the second mode exhibited a symmetric flapping motion. The third mode shape was an underdeveloped s-bending motion. At 37 Hz, the wing exhibited an s-bending mode

shape on the right span with very little movement on the left span. At 40 Hz, the left span exhibited an s-bending motion with very little movement on the right span. These two modes are similar to the third and fourth mode of the wing in Test 1.

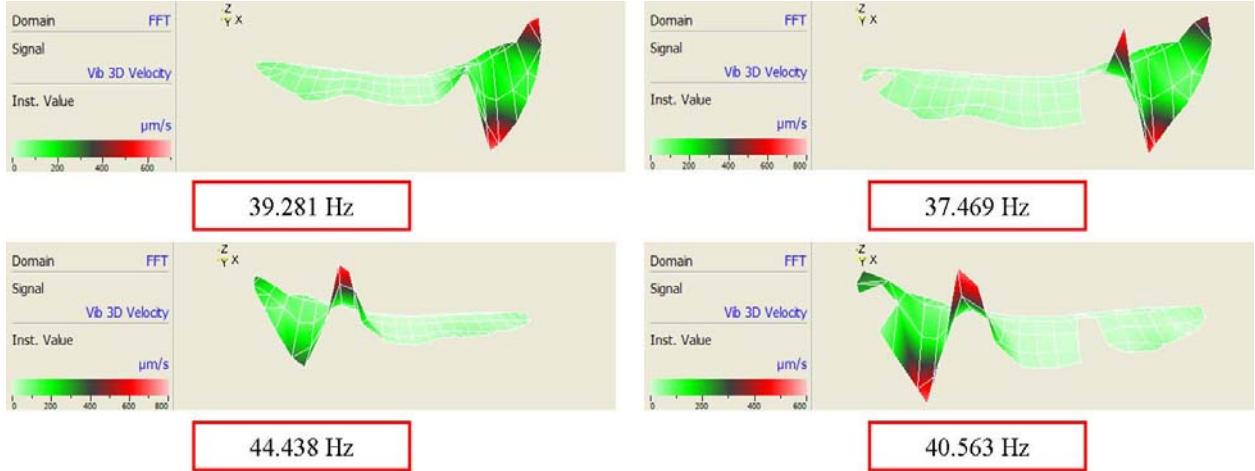
Figure 34: Mode Shape Comparison

In Test 1, the mode shape that exhibited an s-bending motion on the right span with little movement on the left span of the wing was found at 39.281 Hz. In Test 2, this same mode shape was found at 37.469 Hz. There is a drop of approximately 2 Hz after damage was applied to the wing. In Test 1, an s-bending motion on the left span with relatively little movement on the right span of the wing occurred at 44 Hz. In Test 2, the same mode shape was found at 40 Hz, approximately 4 Hz lower. The cause for the drop in frequency is a decrease in the stiffness of the wing after the membrane is removed. The natural frequency of the wing is function of the stiffness over the mass of the wing. With a drop in frequency, it is found that the stiffness has the dominant effect in changing the frequency of the wing.

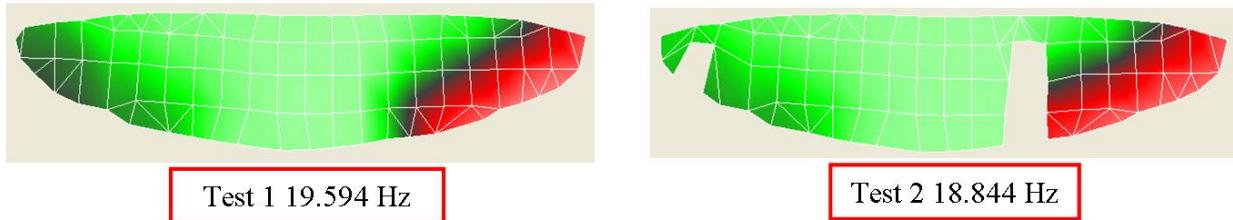
Figure 38: Velocity Comparisons for 19 Hz (Test 1) and 18 Hz (Test 2)

The first frequency comparison is between the wing in Test 1 and 2 at the first natural global frequency for each respective test. The velocities at the selected scanning points can be found in Table 10. The first mode shape for both tests at these frequencies was an asymmetric flapping motion. On the left span of the wing, there is a noticeable increase in velocity for both Index 4 and 147. Index 4 near the tip of the wing had the greatest velocity change, nearly 1.5 times the velocity in Test 1. On the right span of the wing, the frequencies stayed relatively the same between the two tests. The right span of the wing had two detached battens during Test 1. It seems the removal of the membrane near the center of the wing did not change the effect of the removed battens significantly. However, with the battens removed, the membrane of the right span of the wing was allowed to displace larger distances resulting in greater velocities overall compared to the left span.

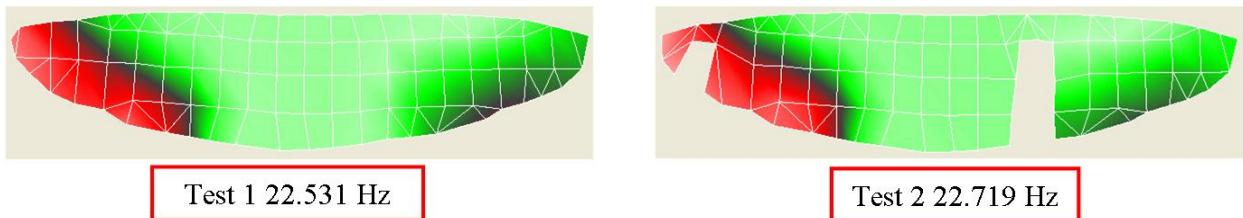
Figure 39: Velocity Comparisons for 22 Hz (Test 1 and Test 2)

The following velocity comparison is at the second mode, which occurred at 22 Hz for both Test 1 and Test 2. The velocities for the scanning points at these frequencies can be found in Table 11. At 22 Hz, the mode shape exhibited by the wing was an asymmetric flapping motion with greater velocities found on the left span of the wing. The greatest velocity change occurred near the tip of the wing around Index 76. The velocity was approximately 1.6 times larger in Test 2 at Index 76. In the comparison of the first mode, the right span stayed relatively the same. The opposite occurred at 22 Hz. The magnitudes of velocity on the left span of the wing stayed somewhat the same while the right span experienced large changes in velocity. At these frequencies, the removal of the batten and its surrounding membrane near the center of the wing had a great effect in allowing the right span of the wing to displace larger distances. On the other hand, the removal of a batten and membrane near the tip of the wing at these frequencies did not have a significant effect.

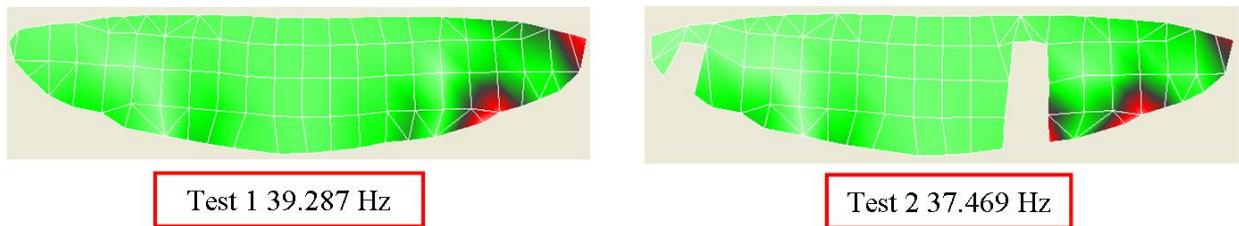
Figure 40: Velocity Comparisons for 39 Hz (Test 1) and 37 Hz (Test 2)

This velocity comparison is at the frequencies where the wing's mode shape exhibited an s-bending motion on the right span of the wing with comparatively smaller velocities on the left span of the wing. Overall, the velocities at this mode were much smaller compared to the velocities for the first two modes compared. These velocities are summarized in Table 12. On the left span of the wing, the greater velocity change occurred near the tip of the wing. On the right span of the wing, the greater velocity change was not found near the tip but rather around Index 103. Moreover, this index point experienced a decrease in velocity. Index 103 is located between damaged areas where the largest velocities were encountered in Test 2. To the left, there is the area where a batten and membrane were removed. To the right is the area where a batten had detached from the membrane of the wing. Index 103 acted like the center of the wing where the two areas on its left and right side were "wings" that resulted in a reduction in velocity at Index 103 but greater velocities at its surrounding areas.

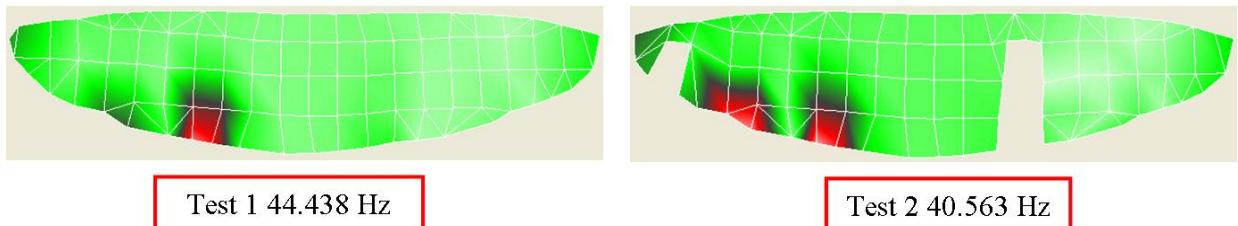
Figure 41: Velocity Comparisons for 44 Hz (Test 1) and 40 Hz (Test 2)

The fourth velocity comparison is between the mode shape that exhibited s-bending motion on the left span with relatively little movement on the right span. This mode shape occurred at 44 Hz during Test 1 and 40 Hz during Test 2. As with the previous velocity comparisons, the velocities found at this mode are much smaller compared to velocities of the first two modes. The greatest velocity change occurred at Index 147, found on the membrane of the left span at the trailing edge. Although the damage was closer to the tip, the removal of the membrane at the tip allowed the rest of the wing to flap more.

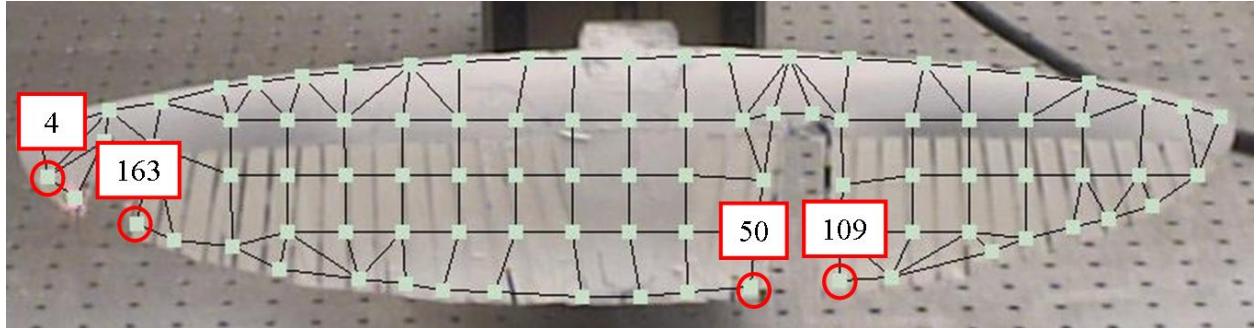
Figure 42: Selected Scanning Points by Damaged Areas

This section compares velocities directly by the damaged areas. The scanning points selected are shown in Figure 42. On the left span of the wing, Index 4 and 163 are located by the area where the batten and its surrounding membrane were removed. On the right wing span, Index 50 and 109 surround the area where the batten and membrane were removed on this span. Also, these two index points surround the area where a batten had detached from the membrane

during Test 1. Comparing velocities at directly at the damage on both sides will help determine which form of damage had a greater affect on the wing.
